## **Cooks River Catchment**

# **2013/14 River Health Monitoring Technical Report**

**Cooks River Alliance**

**July 2014**

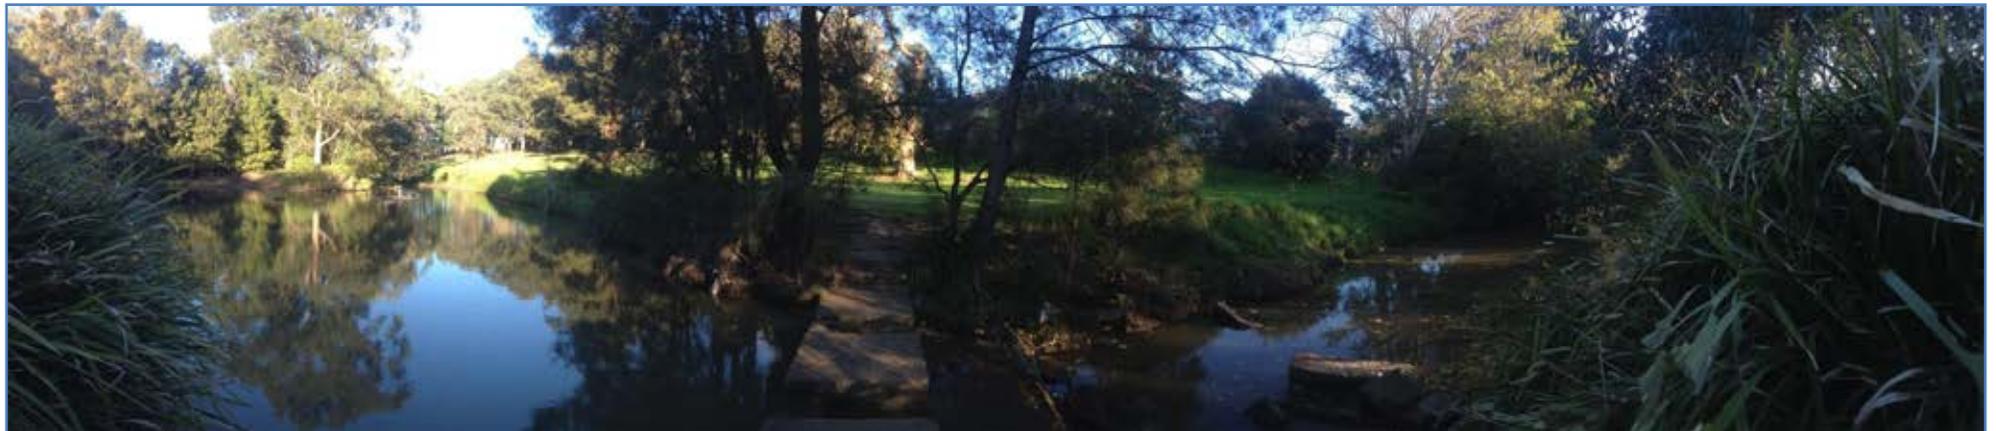
The ecological condition of Bardwell Creek at Coolibah Reserve is poor reflected by an overall River Health grade of D- (Table 4, figure 2). During the 2013/14 monitoring period conditions at this site were typical of a highly urbanised waterway. Creek water was periodically discoloured and turbid with bottom sediments comprised of fine clay and organic material. Creek banks appeared scoured, undercut and eroded (figure 3), reflective of high flows and frequent flooding. A significant amount of litter was present along both creek banks and channel.

Results of water quality monitoring show persistently low dissolved oxygen, frequent nitrogen pollution and occasional elevated phosphorous concentrations. The riparian vegetation community at this site is in poor condition, a result of a narrow vegetation corridor, and lack of complex canopy structure (figure 2). The degraded condition of this site is reflected by the macroinvertebrate community. Results of monitoring indicate low richness and biodiversity with a SIGNAL score indicative of a creek affected by urbanisation.

**Figure 2. Bardwell Creek at Coolibah Reserve monitoring site. Panoramic photograph. Left to right = upstream to downstream.**

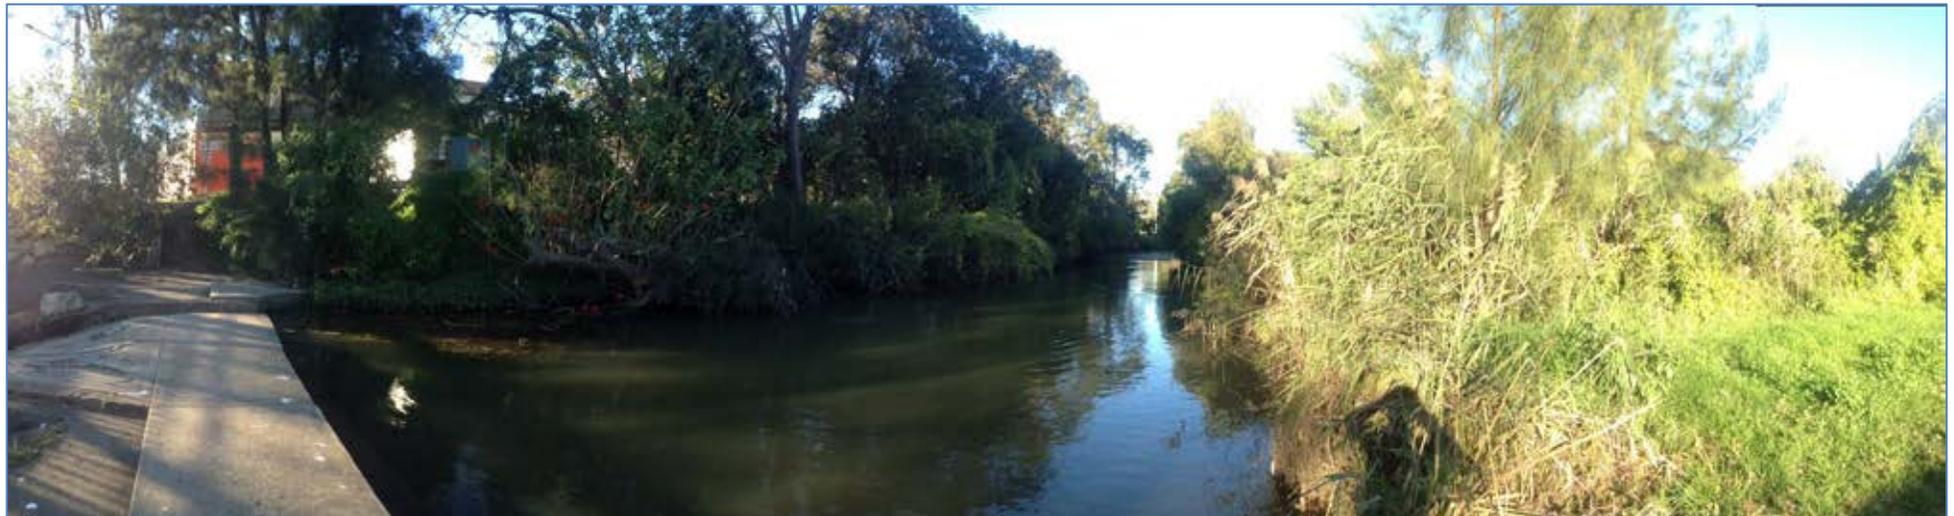
The ecological condition of Wollli Creek at Turrella Weir is poor, reflected by an overall River Health grade of E- (Table 5). During the 2013/14 monitoring periodic surface scum was observed and bottom sediment comprised of building site rubble, litter and fine organic material. Creek banks upstream of Turrella Weir are undercut, a result of high flow and flooding which regularly occurs after periods of intense rainfall. Creek banks have a high cover of invasive weeds; however remnant native species are present (Figure 3).

Results of water quality monitoring show low dissolved oxygen and elevated nitrogen persisted throughout the year. In addition elevated phosphorous and salinity were periodically recorded. The riparian vegetation community at this site is in poor condition. The narrow vegetation corridor, lack of complex canopy structure and high proportion of invasive species contribute to the low River Health grade. Low SIGNAL scores, low richness and low biodiversity index was recorded at this site and is typical of macroinvertebrate communities in degraded urban waterways.

**Figure 3. Wollli Creek at Turrella Weir monitoring site panoramic photograph. Left to right = downstream to upstream.**

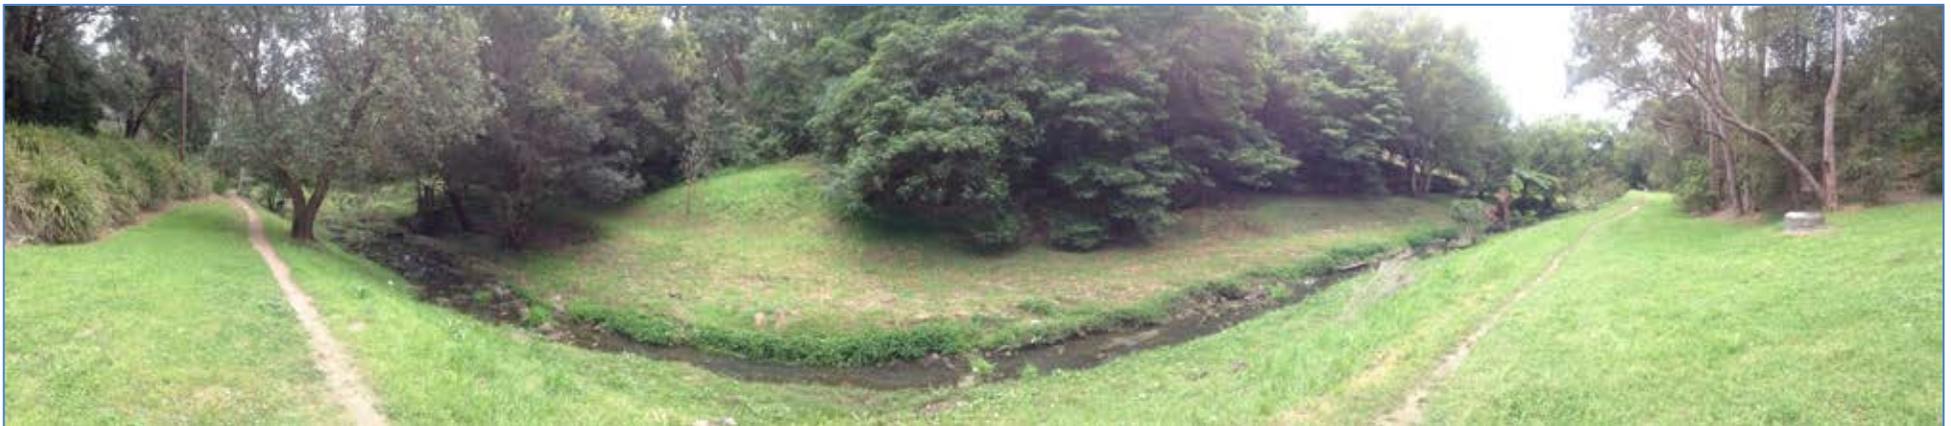
The ecological condition of Upper Bardwell Creek is fair, reflected by an overall River Health grade of C+ (Table 6). During autumn 2014 sampling possible sewage pollution was evident with debris typical of a sewerage overflow observed in parts of the creek. In addition, creek banks and channel were littered with plastics and other debris. The creek channel has been modified with sandstone blockwork and weirs with bottom sediments consisting of fine organic material and larger rocks typical of building debris and road base. A remnant patch of native vegetation, maintaining good condition, is present in this upper section of Bardwell Creek. This is an unusually good feature in such a modified urban catchment (Figure 4).

Results of water quality monitoring show both nitrogen and phosphorus concentrations were above guideline limits in both spring 2013 and autumn 2014 sampling periods. Additionally low dissolved oxygen was recorded in the spring 2013 monitoring period. Although water quality was found to be fair, results of macroinvertebrate monitoring show the in-stream aquatic ecosystem at this site is degraded. A low SIGNAL score is reflected by both low richness and biodiversity which is evidence these site experiences episodes of severe water pollution.

**Figure 4. Upper Bardwell Creek monitoring site panoramic photograph. Left to right = upstream to downstream.**

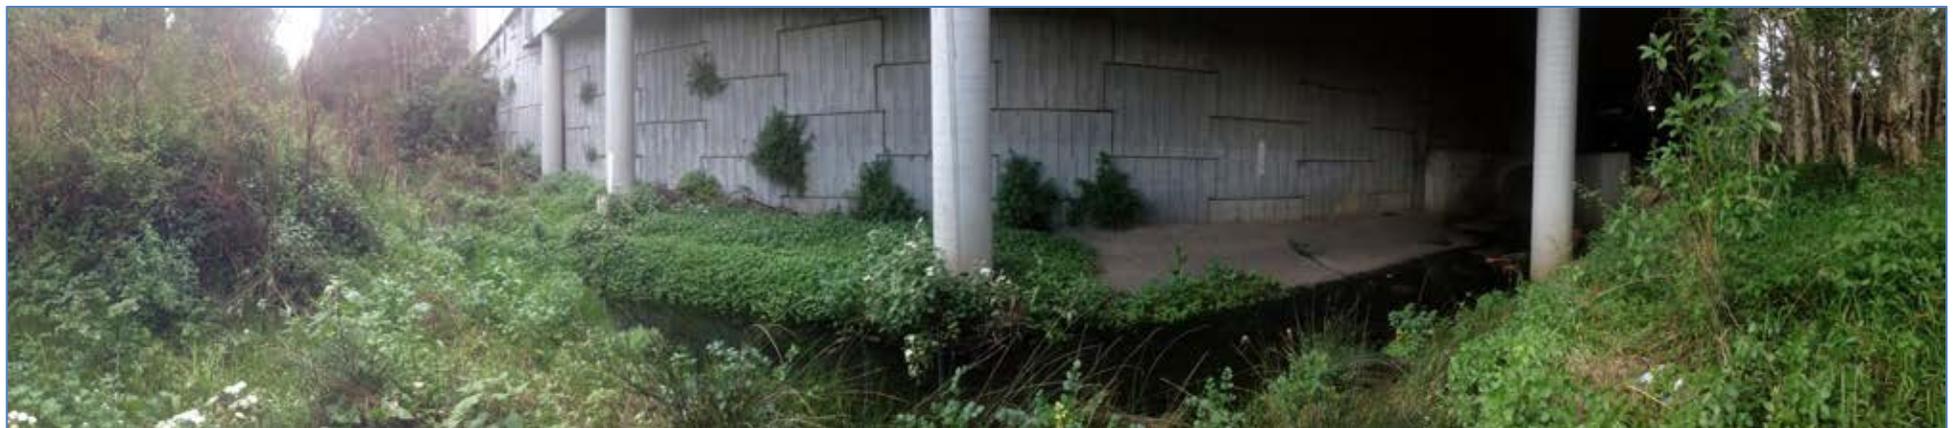
The overall River Health grade for Cox’s Creek is D+ indicating poor ecological condition (Table 7). Cox’s Creek is highly modified with the majority of creek channel being concrete lined. The creek channel at the monitoring site is overgrown with aquatic plants, the majority of which are weeds with only a small and narrow remnant patch of riparian vegetation existing on the southern bank. At the time of sampling the bottom sediment of the creek consisted of fine clays, rubble and building waste (Figure 5). Downstream of the monitoring site the creek is piped to a concrete channel before discharging to the Cooks River.

Water quality monitoring showed most parameters complied with guideline limits; however salinity was up to four and a half times the recommended guideline. This site is above the tidal limit and therefore the source of high salinity is likely derived from upstream anthropogenic sources. It is likely this result, combined with the highly modified nature of the site has an adverse effect on the macroinvertebrate community with low SIGNAL scores, low richness and low biodiversity recorded during both spring 2013 and autumn 2014 sampling seasons.

**Figure 5. Cox’s Creek monitoring site panoramic photograph. Left to right = upstream to downstream**

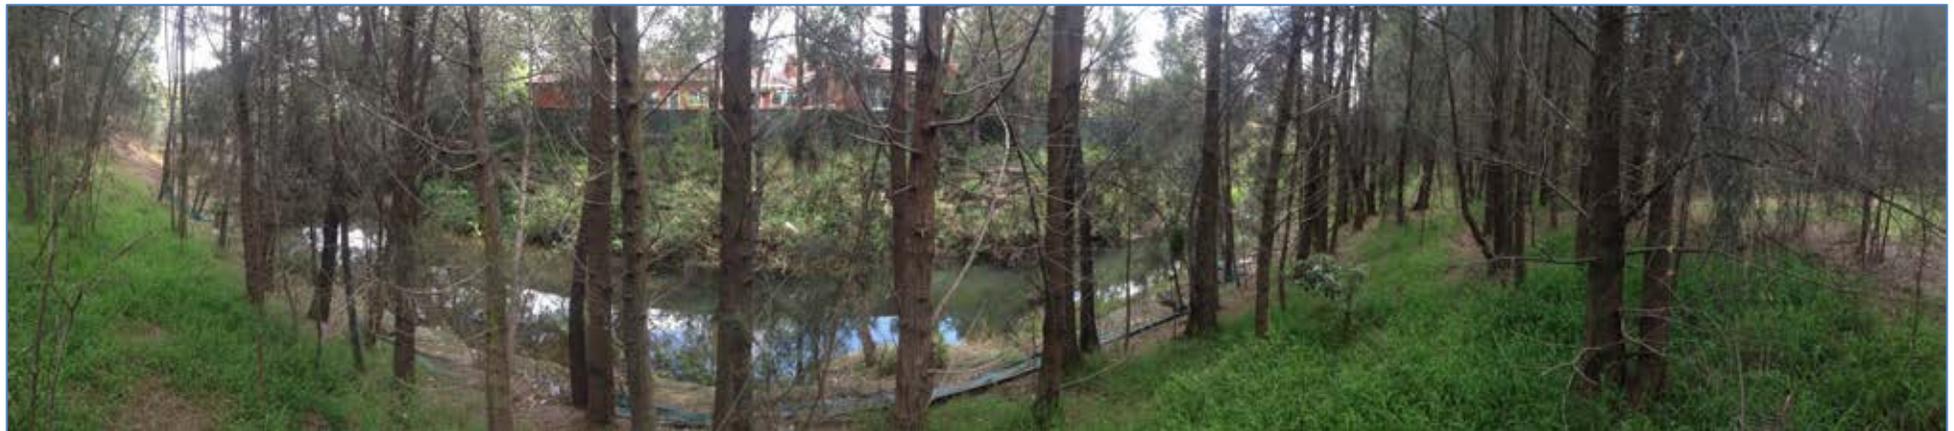
Results of water quality monitoring show most parameters complied with guidelines. However, at times, elevated nitrogen and phosphorous and low dissolved oxygen levels were recorded. Although results of water quality monitoring show conditions were often reasonable, the macroinvertebrate community at this site does not reflect these results. Reduced macroinvertebrate richness and biodiversity are reflected by a low SIGNAL score indicating periodic episodes of urban and/or industrial pollution affect this site. Similar results are common in urban waterways, as results of water quality monitoring provide only a snap shot of conditions at the time samples were collected. However, the macroinvertebrate provide a longer term diagnosis of waterway condition.

**Figure 6. Upper Cooks River monitoring site panoramic photograph. Left to right = downstream to upstream**

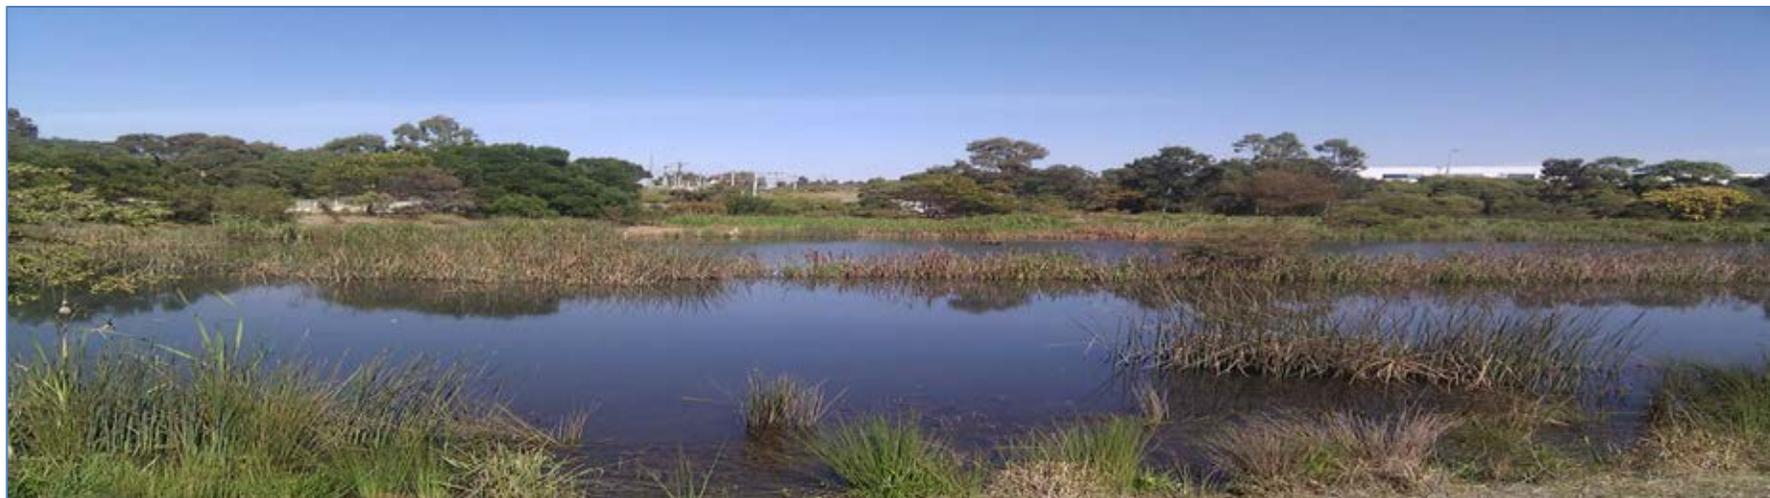
The overall River Health grade for Chullora Wetlands is B- indicating good to fair ecological health (Table 9). Although this site is a constructed wetland designed to capture and treat stormwater, it provides valuable aquatic habitat to a range of bird and frog species. At the time of monitoring, water had a clear appearance and bottom sediment was comprised of fine clay and decaying organic material. The wetland was fringed by thick, and in places impenetrable aquatic vegetation. The riparian vegetation community contained mostly low mid-story shrub and grass species and scattered canopy species (Figure 7). No litter was observed in the wetland during spring 2013 and autumn 2014 sampling periods.

Most water quality parameters complied with guideline limits however low dissolved oxygen was recorded in both spring 2013 and autumn 2014 monitoring periods and high phosphorus in spring 2013. The macroinvertebrate community recorded at this site is the most rich and biodiverse of all Cooks River catchment monitoring sites. However, low SIGNAL scores, influenced by the low abundance of pollution sensitive macroinvertebrates, indicate degradation due to urban and industrial stormwater, a result which would be expected given the surrounding landuse and purpose of this site.

**Figure 7. Chullora Wetlands monitoring site panoramic photograph (source streamwatch.org)**

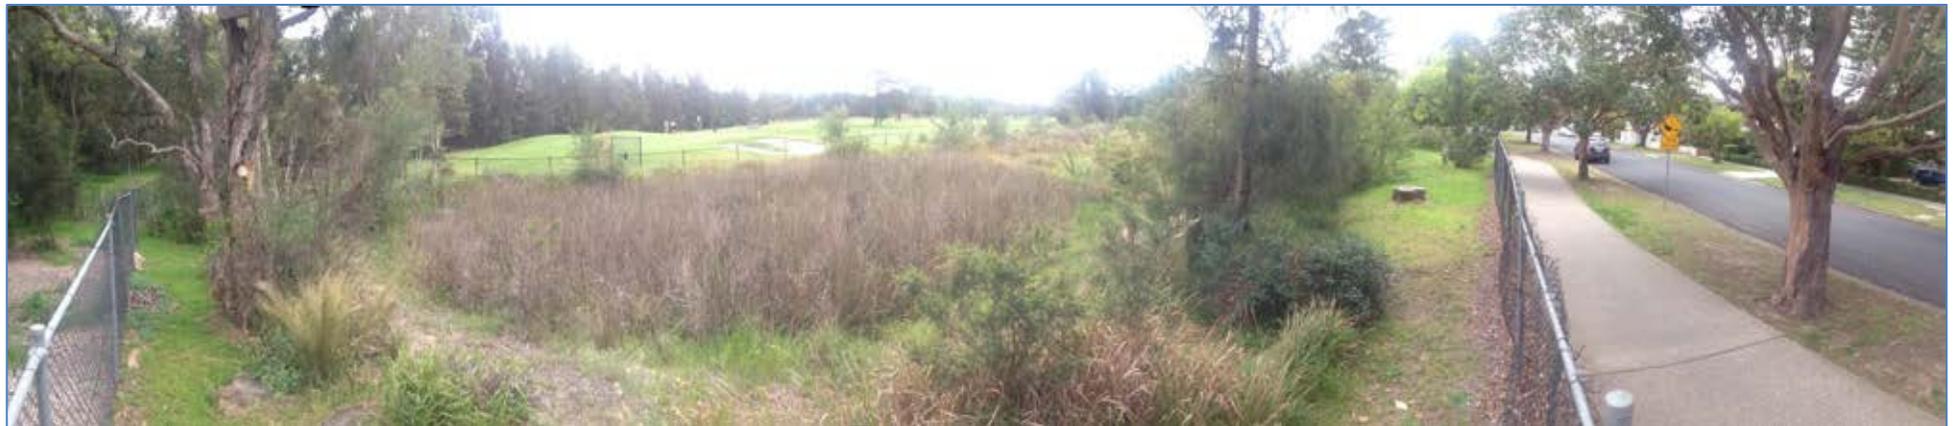
The ecological condition of Yarrowee Road Wetland is poor, a result which is reflected by an overall River Health grade of F- (Table 10). This site is a constructed wetland designed to capture and treat stormwater and in extended periods of low rainfall, surface water dries up resulting in the loss of aquatic habitat. During the 2013/14 monitoring period wetland vegetation was thick and dominated by aquatic plant species however the fringing riparian vegetation community lacked canopy complexity and habitat value (Figure 8). A thick algal mat was present in the wetland and bottom sediment consisted of thick layer of fine silt and decaying organic materials. Some aquatic weeds were observed in the wetland outlet channel.

During the spring 2013 monitoring period the wetland was dry and no monitoring was undertaken. However, autumn 2014 water quality monitoring results show dissolved oxygen, turbidity, nitrogen and phosphorus levels were outside guideline limits. Poor water quality combined with dry periods and silty, organic bottom sediment provide less than ideal conditions to support a diverse macroinvertebrate community. Low macroinvertebrate richness, biodiversity and SIGNAL score reflect the degraded condition of the aquatic ecosystem at this site.

**Figure 8. Yarrowee Wetland monitoring site panoramic photograph.**

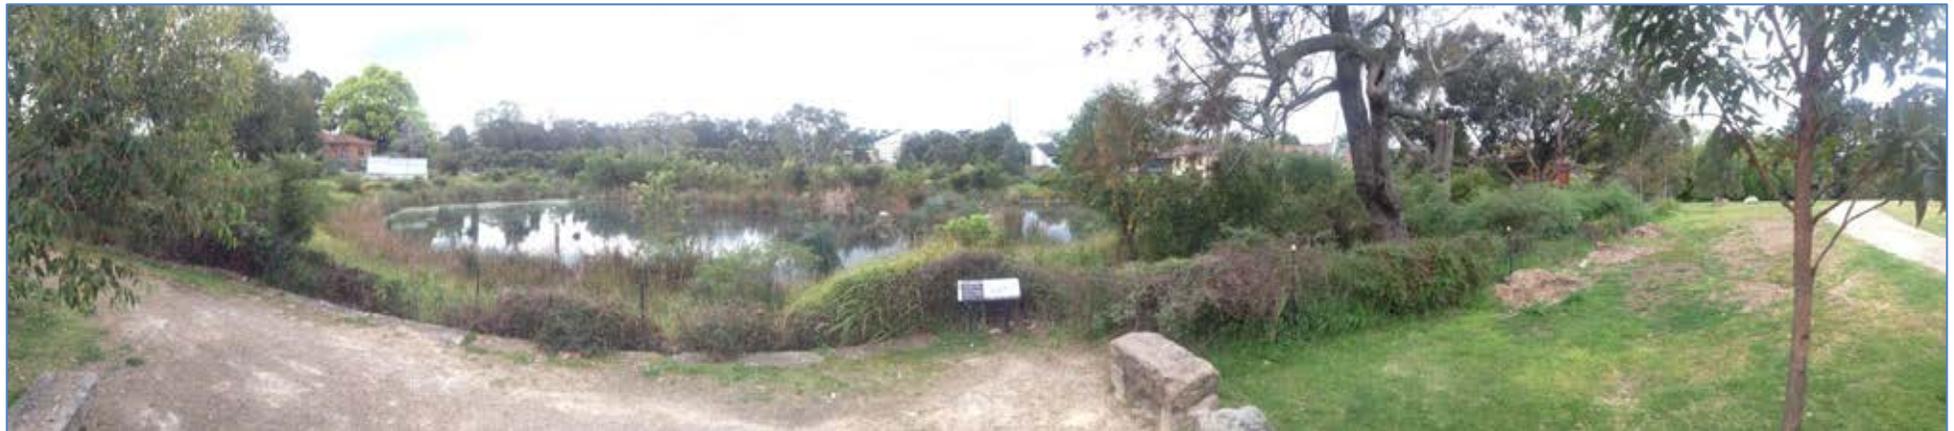
The overall River Health grade for Cup and Saucer wetlands is F+ indicating very poor ecological health (Table 11). Although this site is a constructed wetland which is designed to capture and treat stormwater the size of the treatment area is less than desired to effectively treat flows from the catchment (pers. comms. Canterbury City Council). However this site provides important habitat to a range of bird species and amenity to local residents. At the time of monitoring water had a turbid appearance and bottom sediment was comprised of a thick layer of fine silt and decaying organic matter. The wetland was fringed by thick, and in places impenetrable aquatic vegetation and the surrounding riparian vegetation community contained mostly native low mid-story shrub and grass species with few non-native weed species observed (Figure 9). No litter was observed in the wetland during spring 2013 and autumn 2014 sampling periods.

**Figure 9. Cup and Saucer Wetland monitoring site panoramic photograph.**

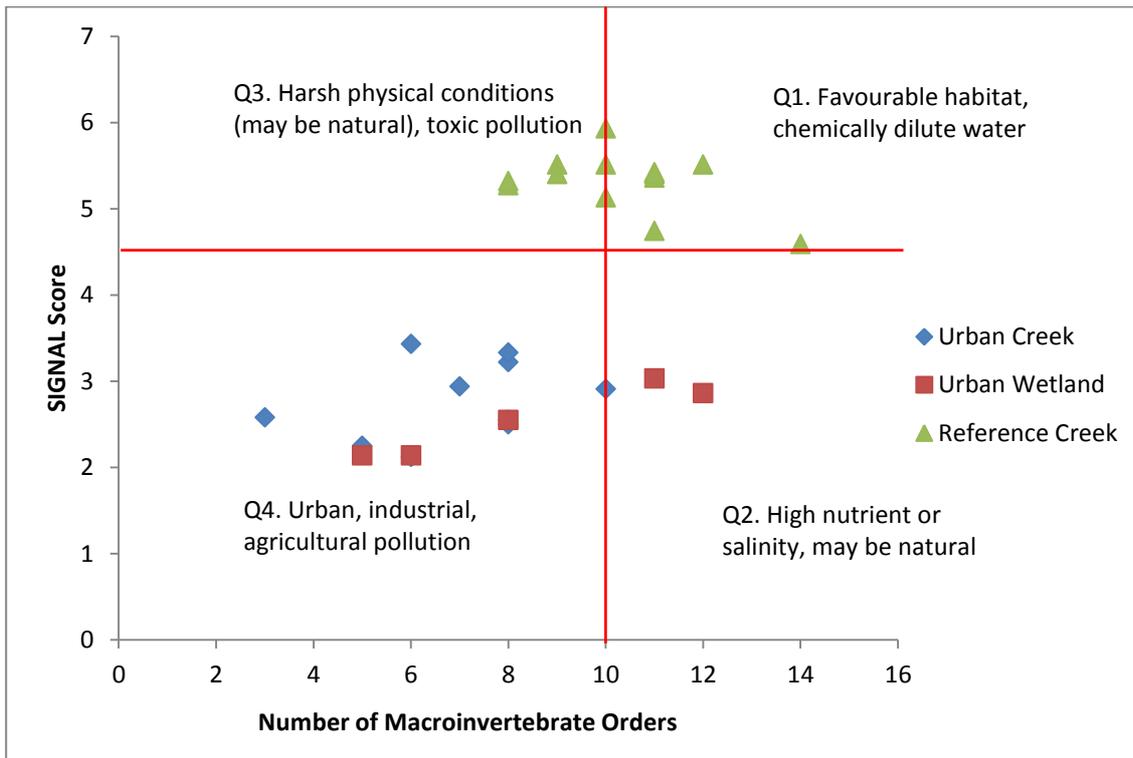
Boundaries in the SIGNAL vs macroinvertebrate family richness bi-plot (Figure 10) have been set following the rational set out by Chessman (2003) using reference creek data from the Georges River catchment collected during spring 2013 and autumn 2014. These reference sites are not located in the Cooks River catchment and represent the nearest non-urban 'natural' streams.

Results of monitoring show all Cooks River waterways fall within quadrants two and four, indicating environmental conditions at these sites are affected by urban and/or industrial pollution and high nutrient and/or salinity.

**Figure 10. Bi-plot of SIGNAL scores and order richness from 2013/ 2014 macroinvertebrate sampling of Cooks River catchment waterways and reference streams in the Georges River catchment.**

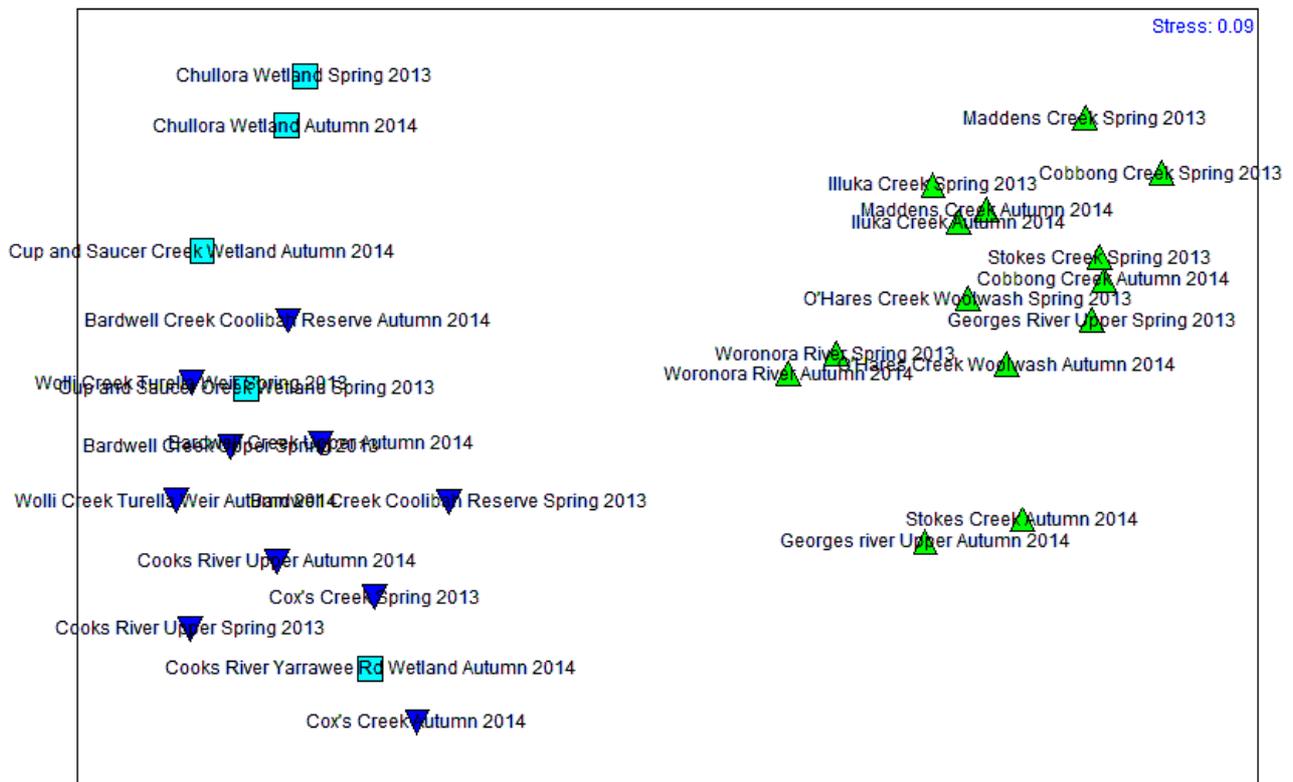
The pattern of community structure dissimilarity between waterway class can be seen in the nMDS 2-D ordination with reference creek samples (green triangles) clustering separately and discreetly from all other samples. In contrast, urban wetlands (blue squares) and urban streams (blue triangles) show a pattern of overlap, indicating community structure similarity between these urban waterway classes (Figure 11).

**Figure 11. NMDS plot (4th root transformed data) of macroinvertebrate community structure for Cooks River waterways and reference streams, spring 2013/autumn 2014. Samples grouped according to waterway classification. Green triangles = reference stream, blue triangle = urban stream and blue square = urban wetland.**

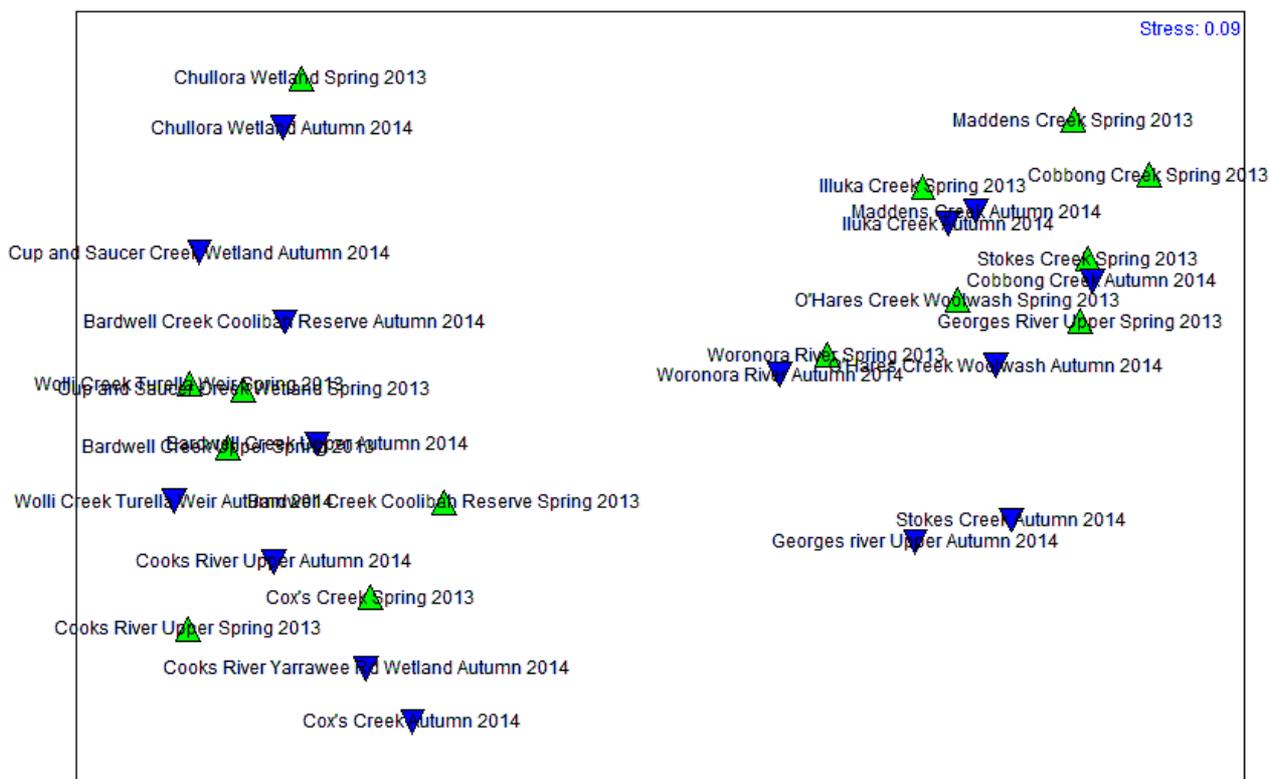
Seasonal differences in macroinvertebrate community structure between spring 2013 and autumn 2014 samples are not evident in the NMDS plot (Figure 12). Spring and autumn samples show a high degree of overlap with no discrete clustering. However, the pattern of difference between waterway categories is evident in Figure 12.

**Figure 12. NMDS plot (4th root transformed data) of macroinvertebrate community structure for Cooks River waterways and reference streams, spring 2013/autumn 2014. Samples grouped according to season of sampling. Blue triangle = autumn 2014 and green triangles = spring 2013**

Results of the ANOSIM procedure confirm patterns seen in ordination plots and reveal macroinvertebrate community structure varied significantly according to waterway classification (reference stream, urban stream and urban wetland) (Global R = 0.886, p = 0.001). Community structure of reference sites varied significantly when compared to urban streams (R=0.993, p = 0.001) and urban wetlands (R=0.994, p=0.001). In contrast differences in macroinvertebrate community structure of urban streams and urban wetlands were not significant and no seasonal difference was evident.
